SUMMARY

31 Greenway Circle, Brighton, ON August 16, 2022

Report No. 1062

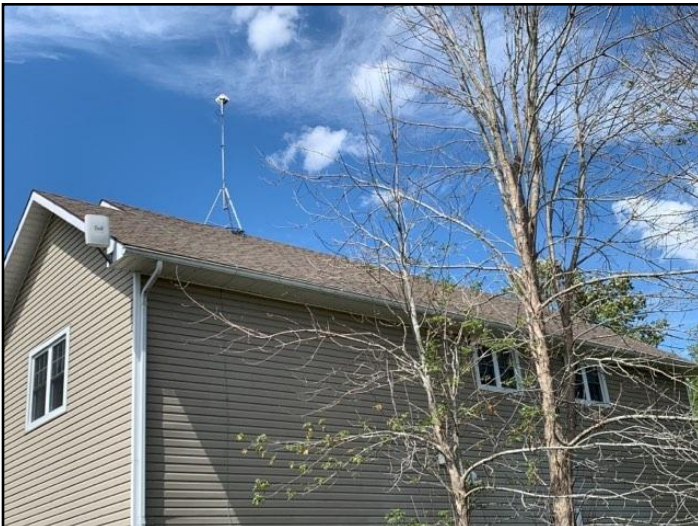
1. Right

2. Condition: • Aging

Shingle aging typical at approximately 12 years.

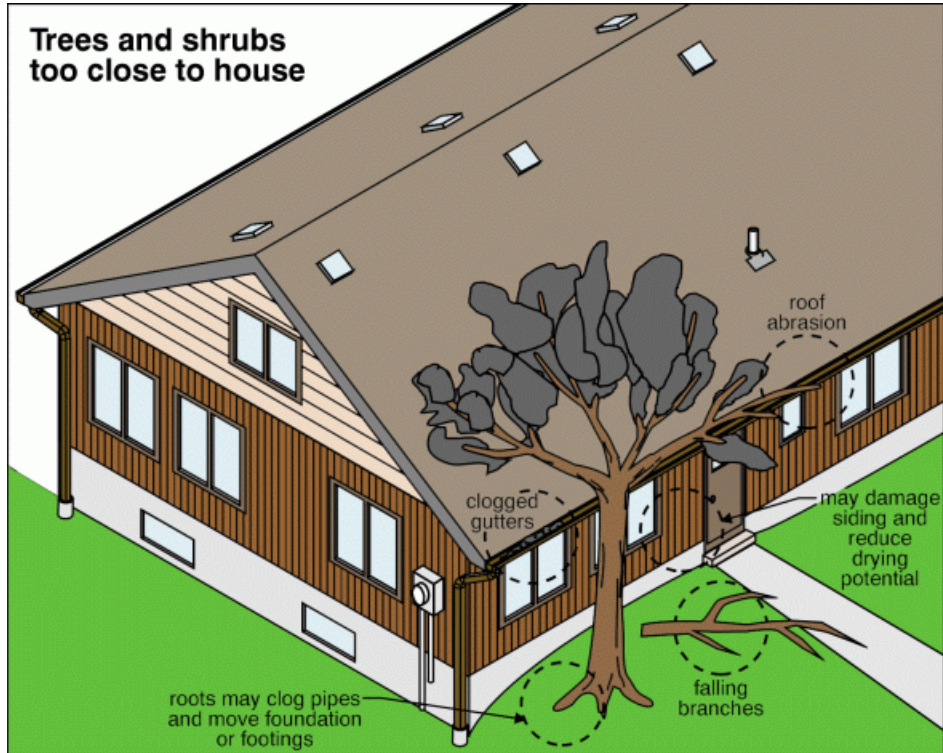
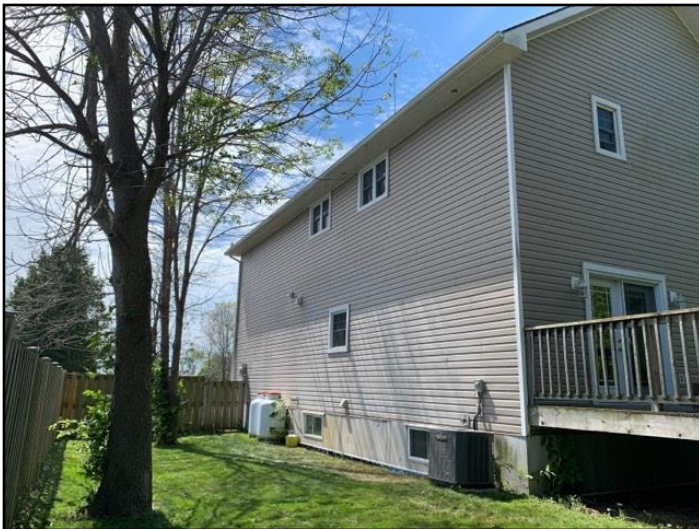
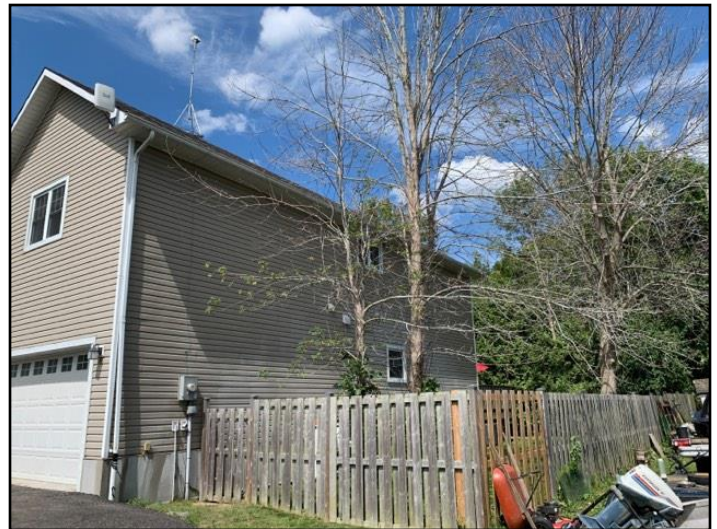
3. Condition: • Tree branches touching roof

Tree branches may cause immediate failure of roofing material and damage to other systems such as fascia or soffit. They also offer excellent opportunity for rodent access to home.

Implication(s): Shortened life expectancy of material

Location: Right side

Task: Remove

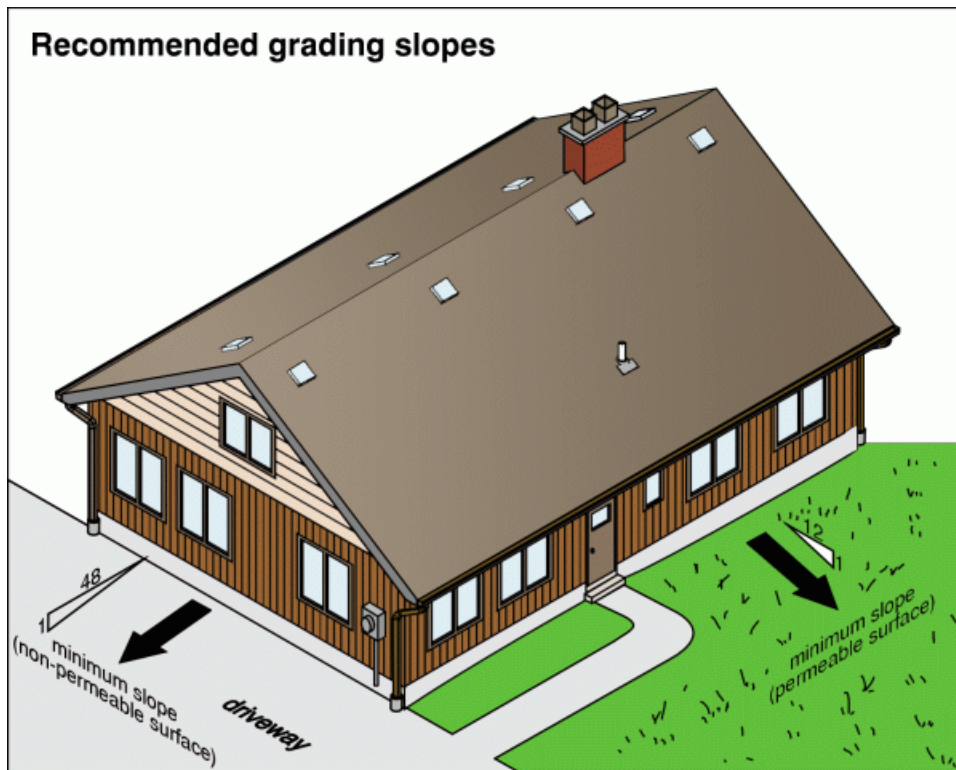
4. Condition: • [Improper slope or drainage](#)

Lot is mostly flat +/- Ideal conditions provide a slight grade away from home to about 6 to 8 feet.

Implication(s): Chance of water damage to structure, finishes and contents

Task: Improve Monitor

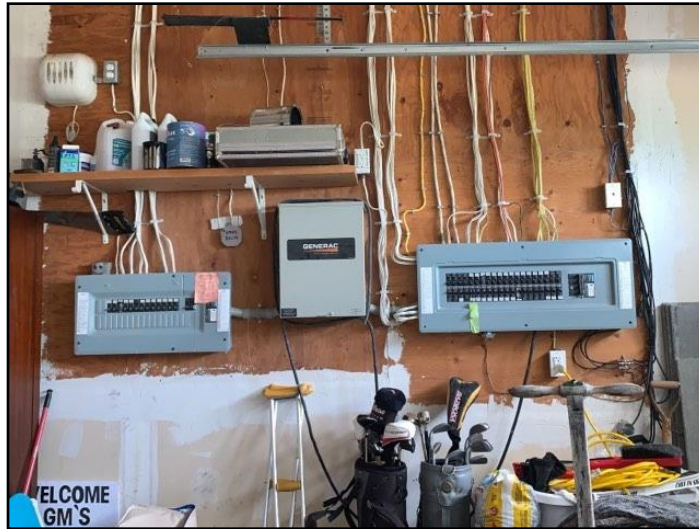
8.

Main panel with generac switch.

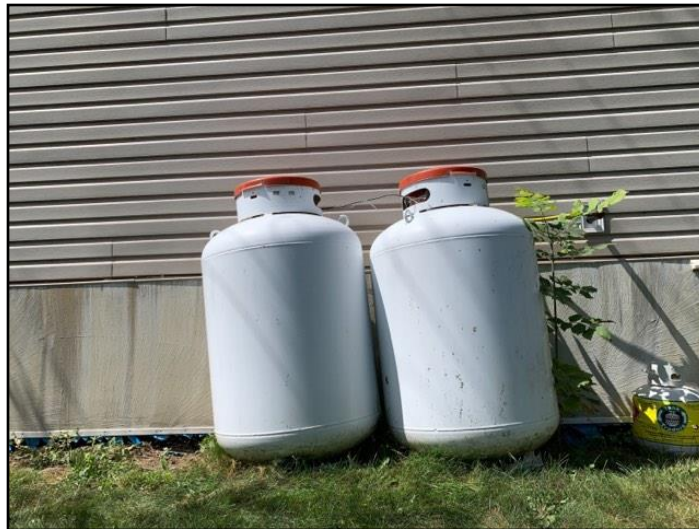
9.

7. Condition: • Provide stable pad for LP Gas tanks

Implication(s): Gas leak.

Task: Provide Improve

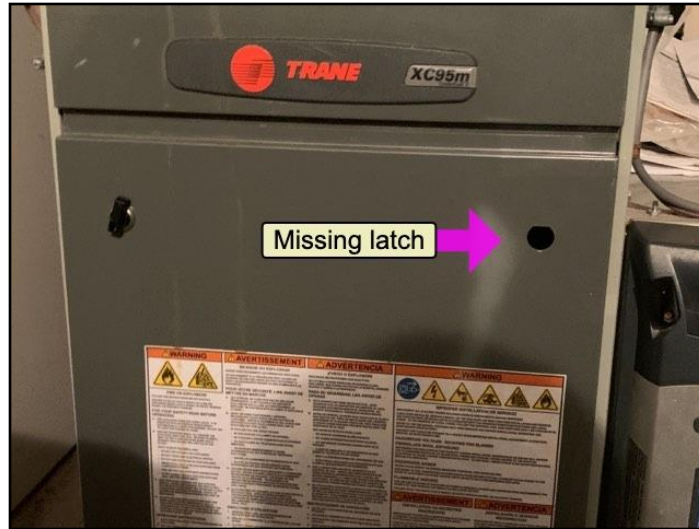
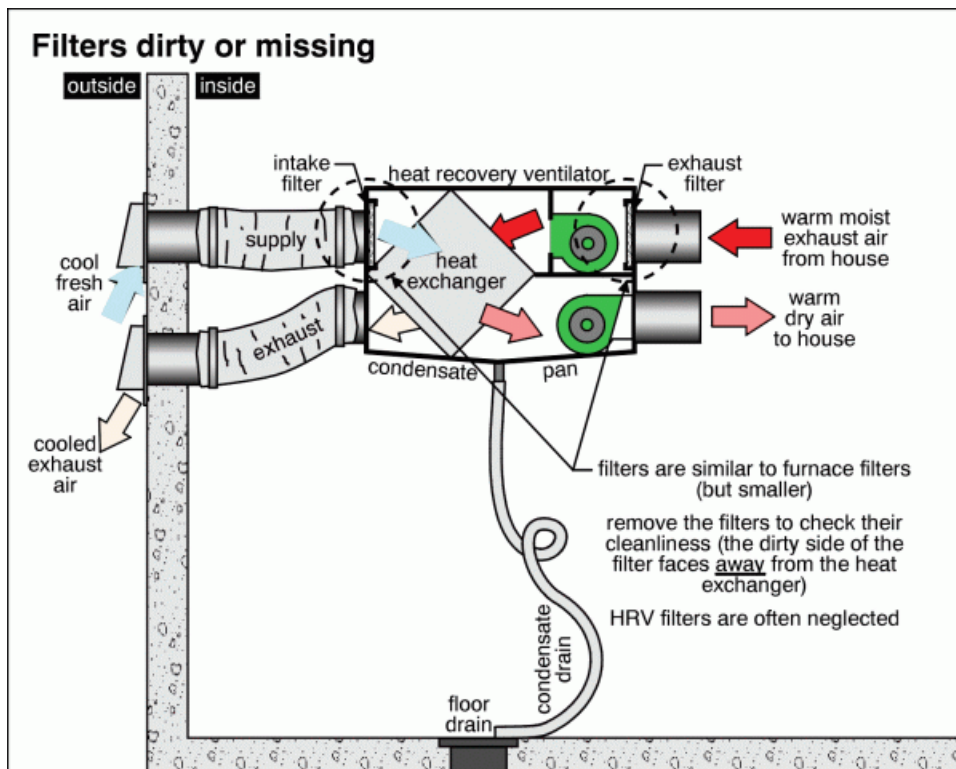
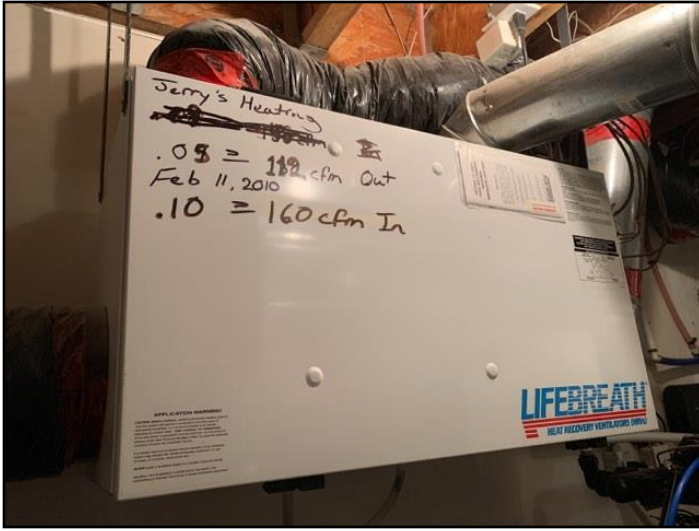
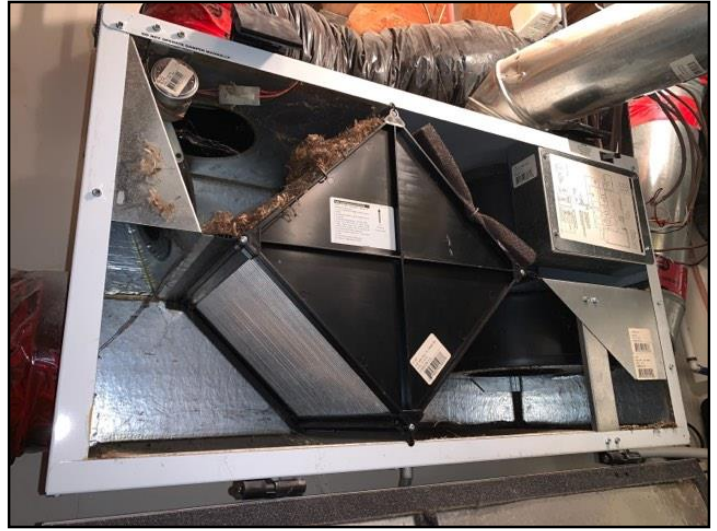
9. Condition: • [Dirty](#)

Implication(s): Equipment ineffective

Task: Service

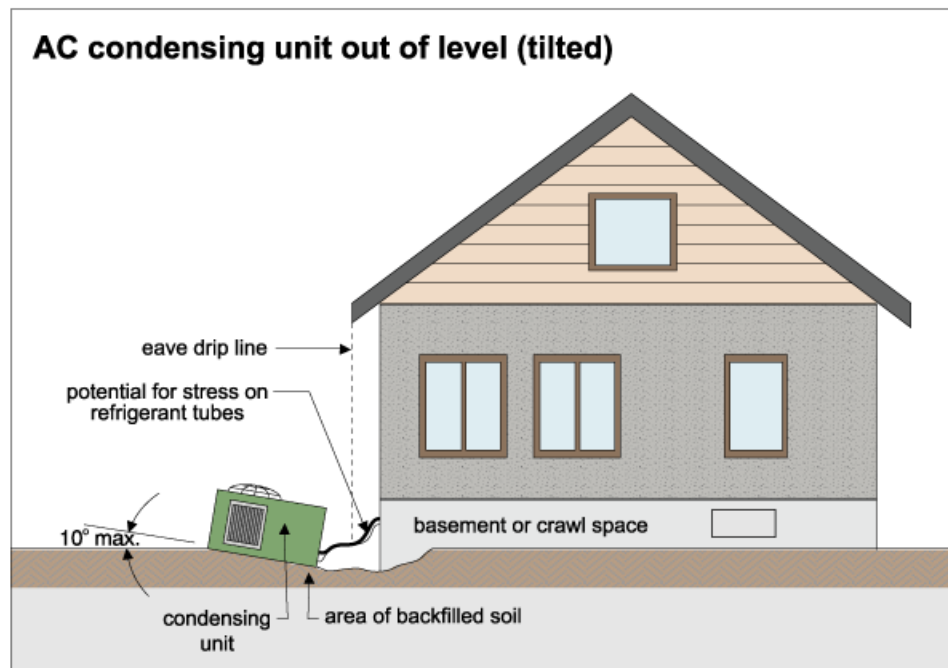
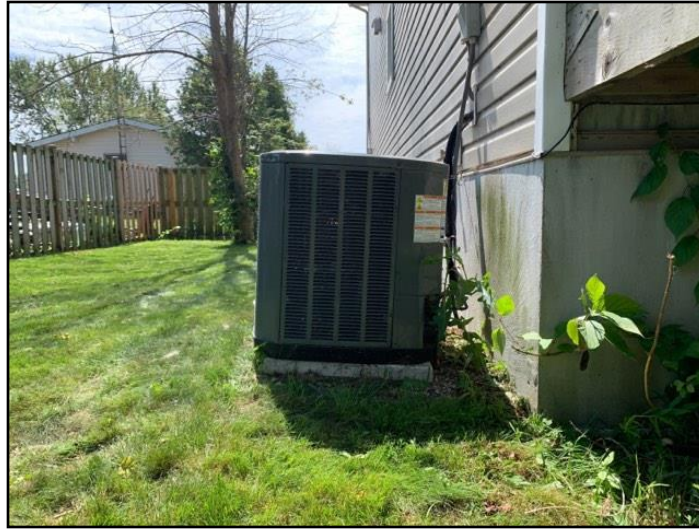
11. Condition: • [Out of level](#)

Implication(s): Reduced system life expectancy | Damage to equipment

Improve when servicing.

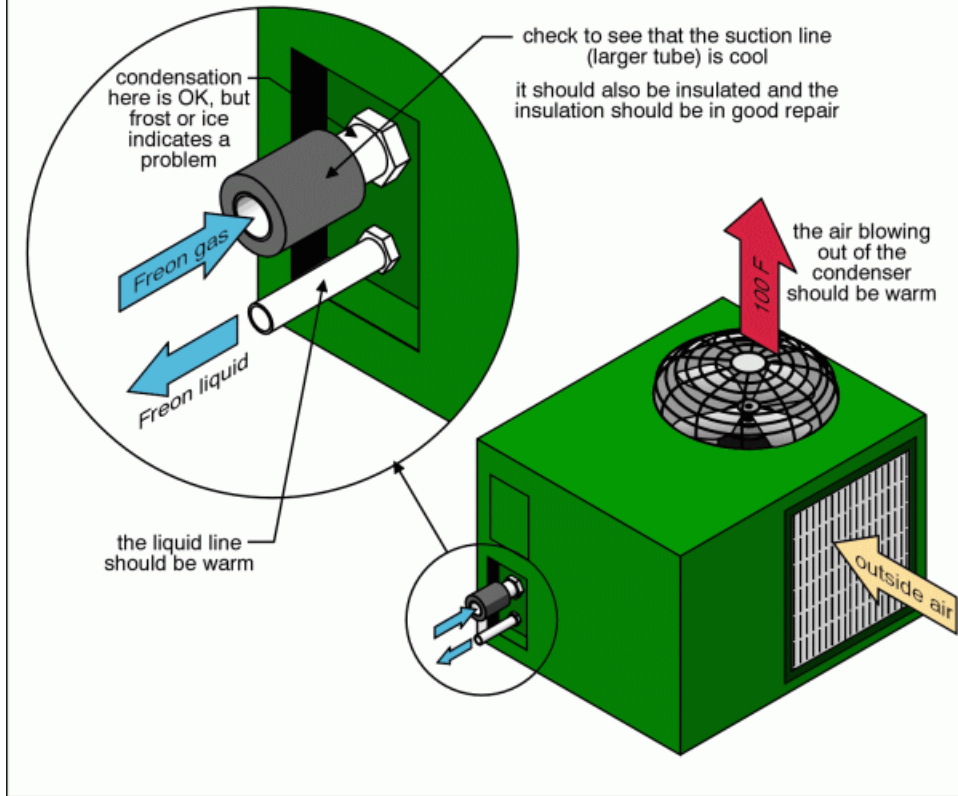
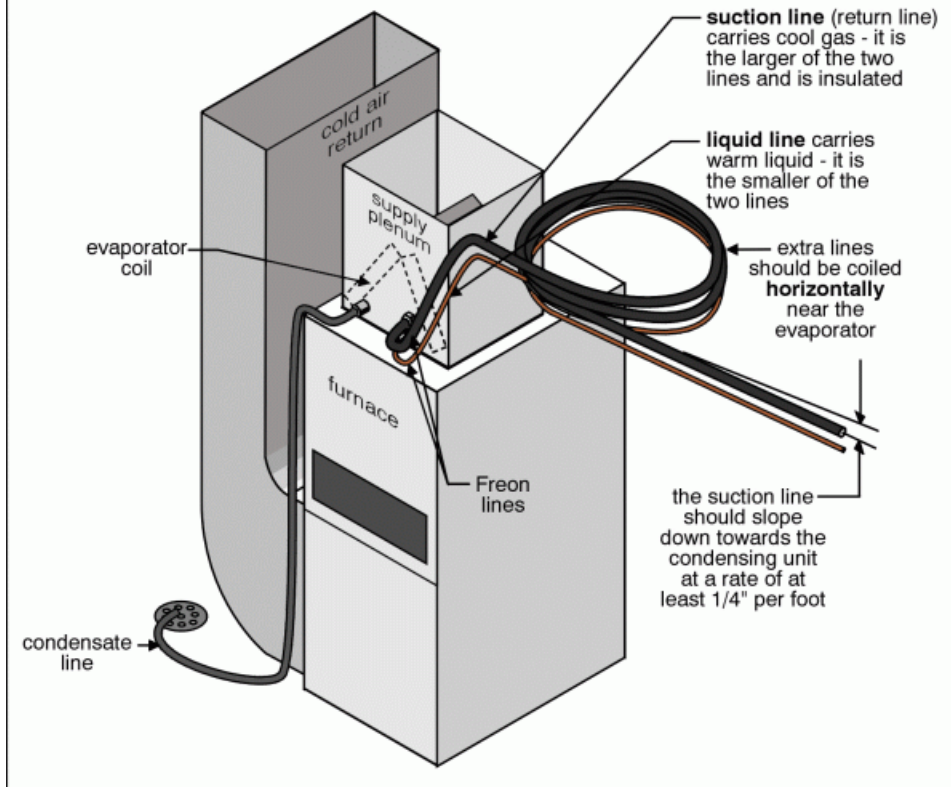
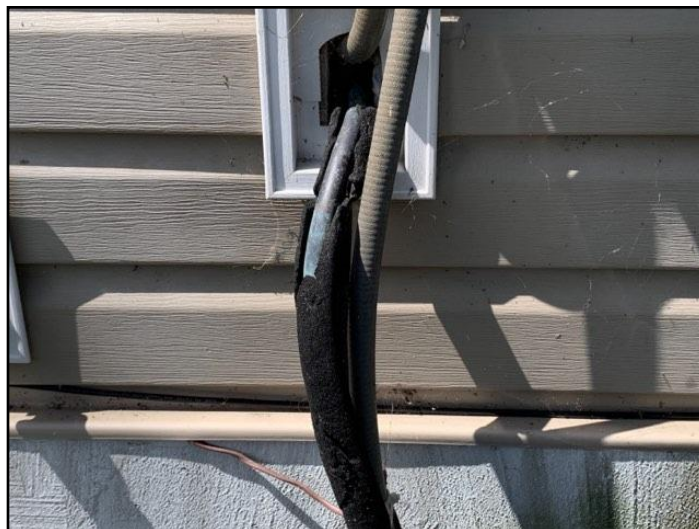
Refrigerant lines

12. Condition: • [Insulation - missing](#)

Implication(s): Reduced system life expectancy | Increased cooling costs | Reduced comfort

Task: Provide

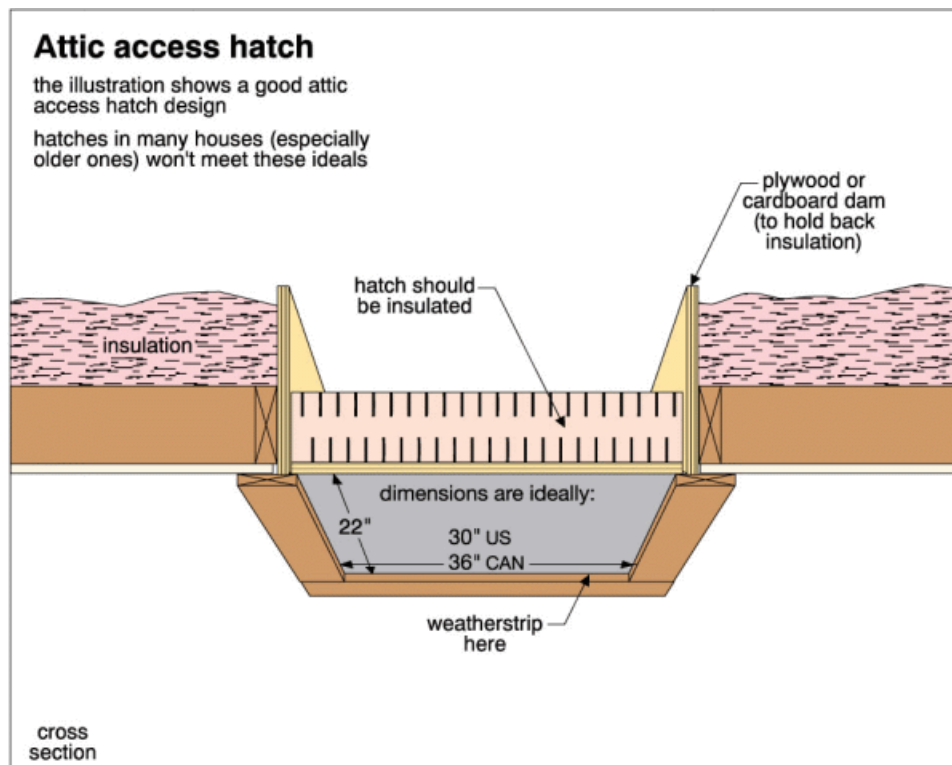
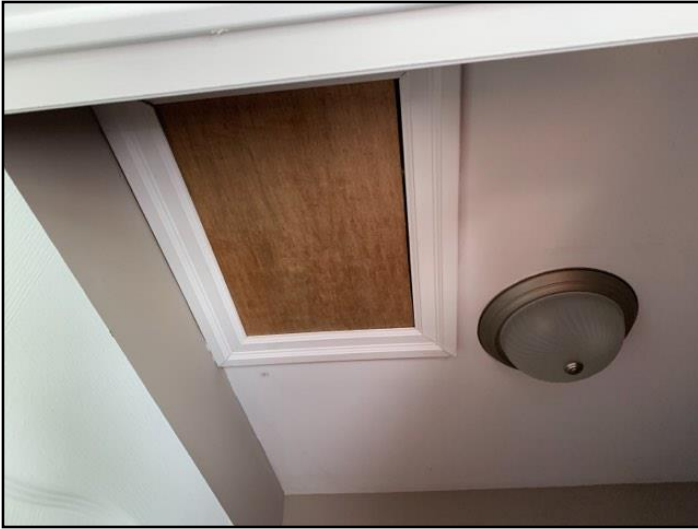
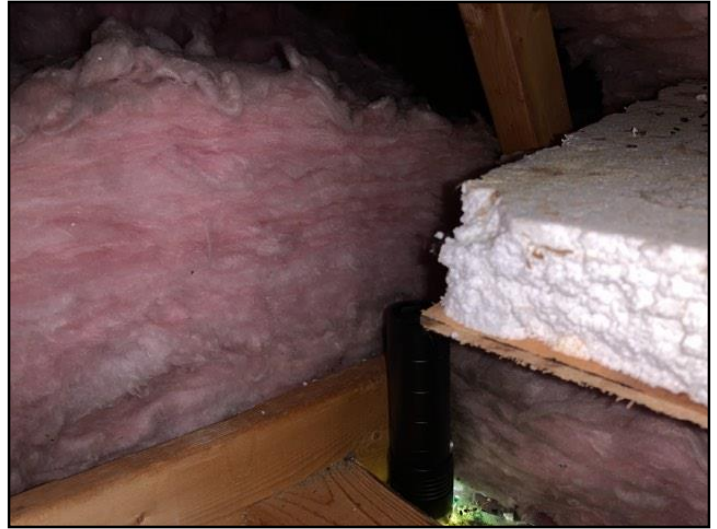
13. Condition: • [Not insulated and not weatherstripped](#)

Poor fit.

Implication(s): Chance of condensation damage to finishes and/or structure | Increased heating and cooling costs | Reduced comfort

Task: Improve

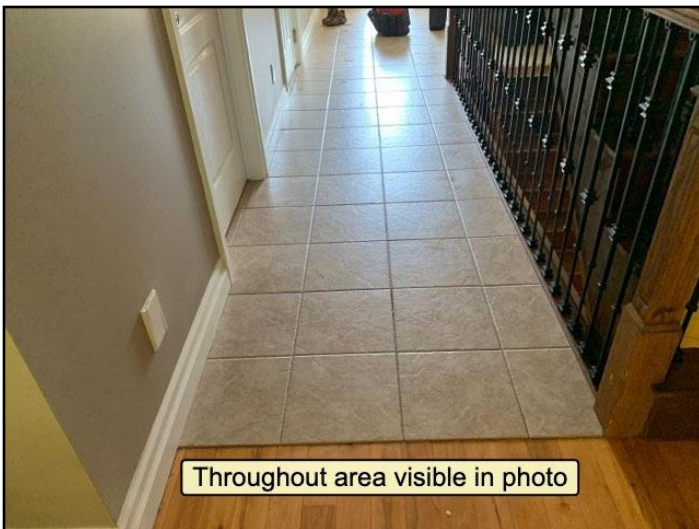
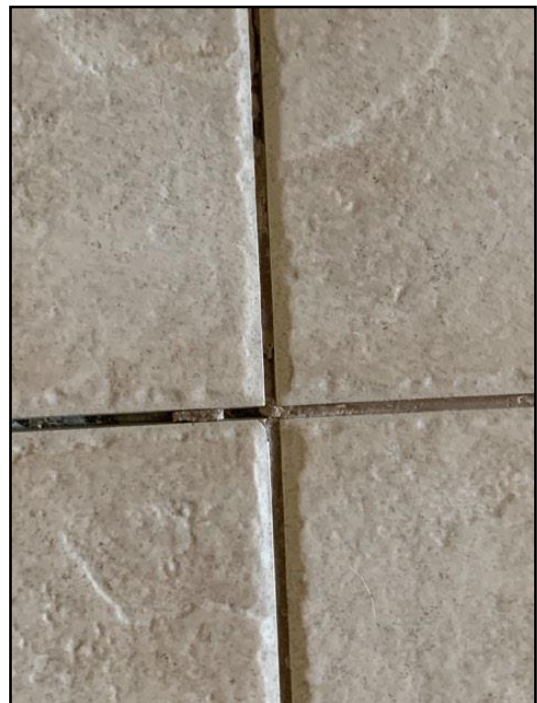
17. Condition: • [Grout missing](#)

Implication(s): Trip or fall hazard

Task: Repair

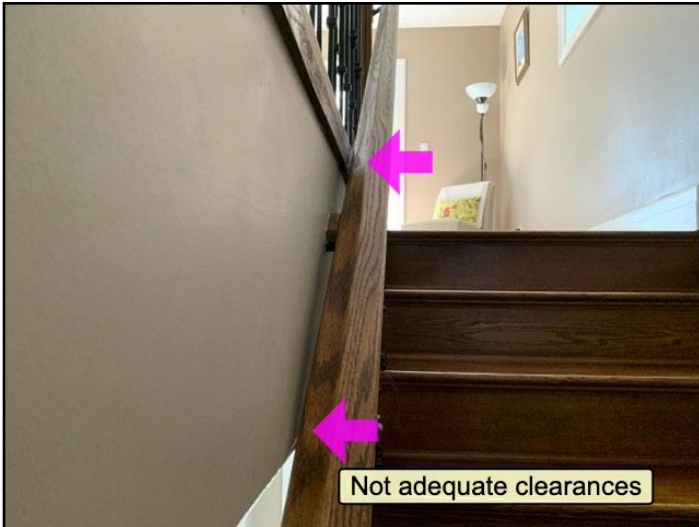
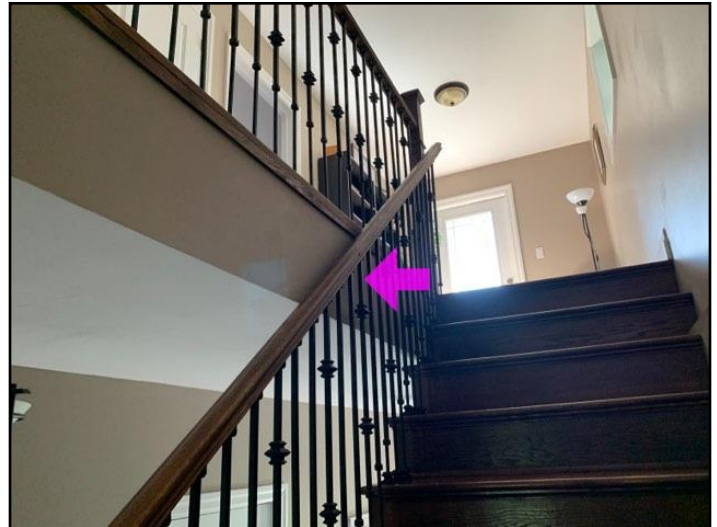
18. Condition: • [Hard to hold](#)

Pinch point. Risk of hand injury and fall.

Implication(s): Fall hazard

Task: Improve Correct

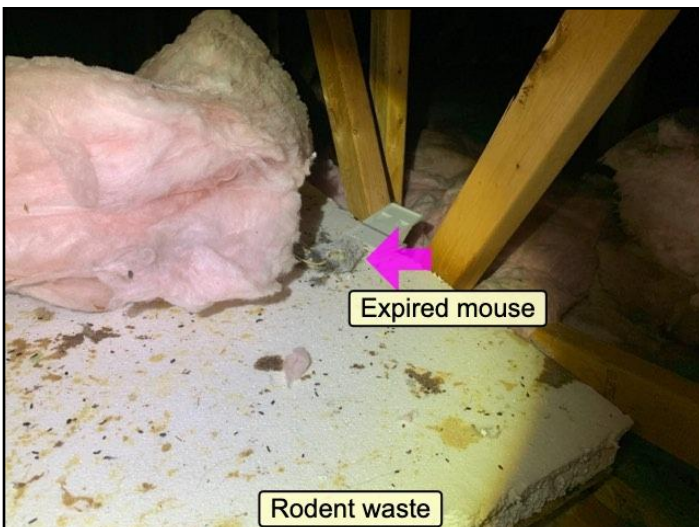
24. Attic hatch

19. Condition: • Rodent/mice activity at vicinity of attic hatch.

Implication(s): Rodent damage to home systems, insulation. Risk to health.

Task: Further evaluation

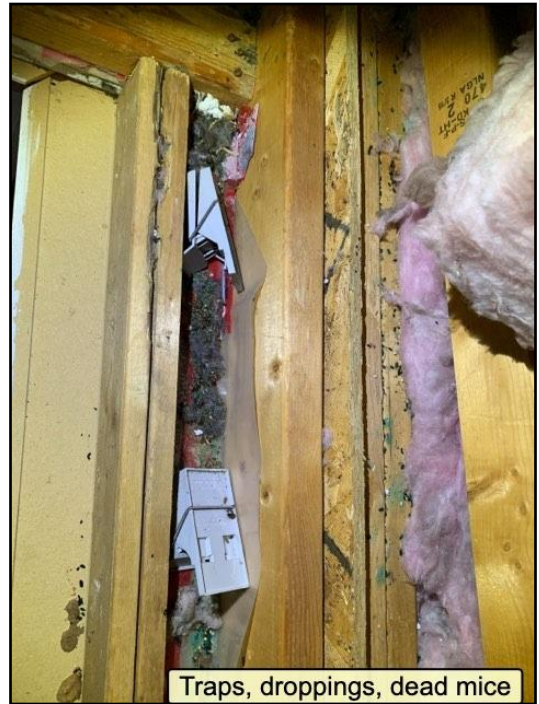
25.

Traps, droppings, dead mice
