PAUL GALVIN
Residential Home Inspections

Inspection Report

Property Address:
301 Carnegie #106
Peterborough

Date: 2022-03-27	Time:	Report ID:
Property: 301 Carnegie #106 Peterborough	Customer: Jeff Sands	Real Estate Professional: Jeff Sands Ball Realty

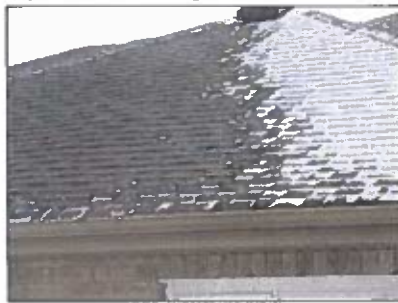
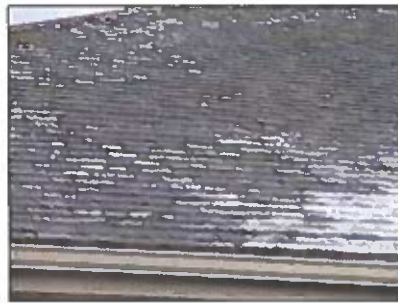
1.0 Picture 1

The entire roof surface is asphalt shingles. The shingles appear to be in good overall condition. They are installed well with all of the necessary caps and flashings.

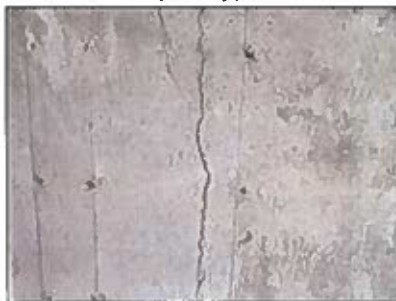
2.1 Picture 1

There is a slight crack in the garage foundation. This is quite typical and is not a structural concern.

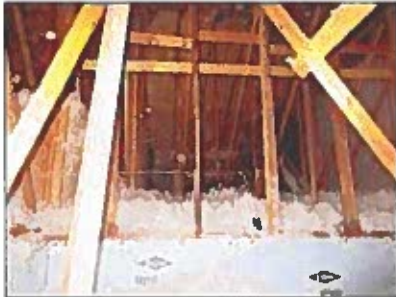
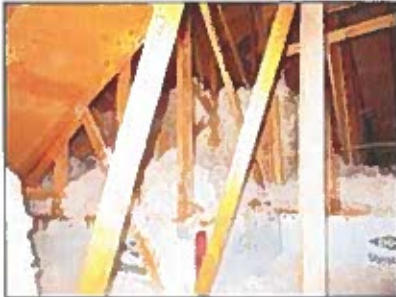
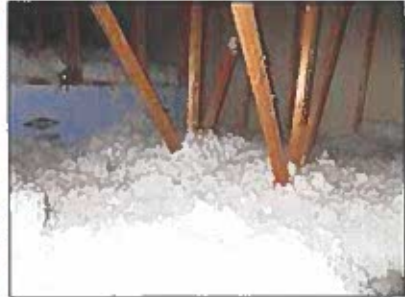
4.0 Picture 1

The attic contains blown in fiberglass insulation. This insulation appears to be well placed and installed in adequate amounts.

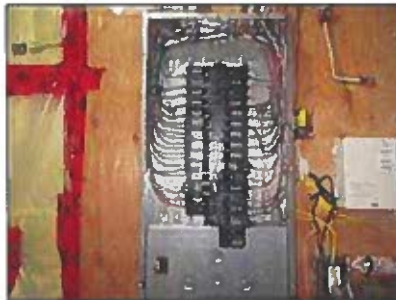
5.2 Picture 1

The main electrical panel was inspected and found to be installed properly and wired correctly. All of the proper sized breakers were present.

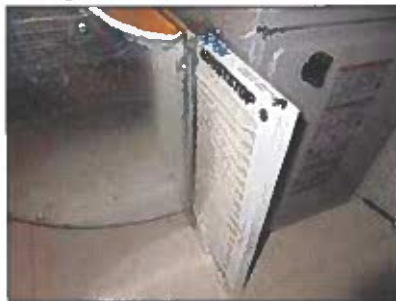
6.0 Picture 1

- (1) The furnace was tested and inspected and found to be installed properly and working well. All the necessary safety features were present.
- (2) The furnace filter should be changed on a regular basis.

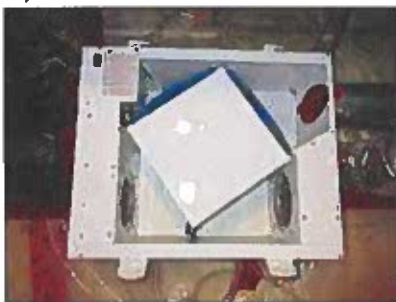
6.10 Picture 1

(1) The heat recovery ventilator filters including the outside fresh air intake screen will require cleaning on a regular basis (see manufacturers recommendations).

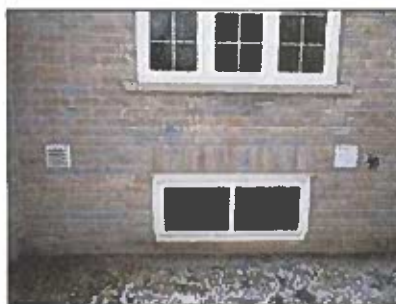
6.10 Picture 2

(2) The exterior vents for the heat recovery ventilator are installed improperly. One of these vents is supposed to exhaust stale air out and the other is supposed to bring fresh air in. The one to the right has flaps on it that open out when air exhausts out. However this vent is supposed to bring fresh air in. The two vents should be swapped with each other.

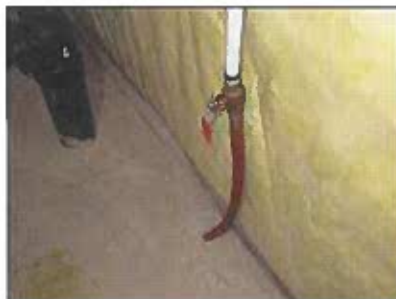
7.4 Picture 1

Front wall of basement.

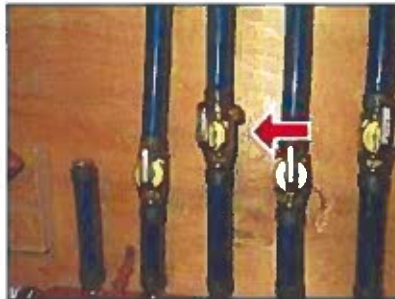
7.11 Picture 1

The outside taps should be shut off and drained before winter.

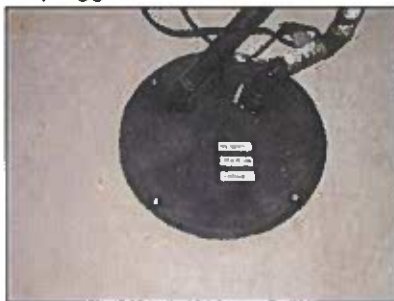
7.12 Picture 1

The sump pump should be tested on a regular basis to ensure its proper operation. The sump pump was unplugged at the time of the inspection. This should be left plugged in.
